SUBJECT John Anglin, Clarence Anglin and
Frank Lee Morris Escape from Alcatraz

FILE NUMBER 76-26295

VOLUME NUMBER Enclosures 76, 137, 155 and 179

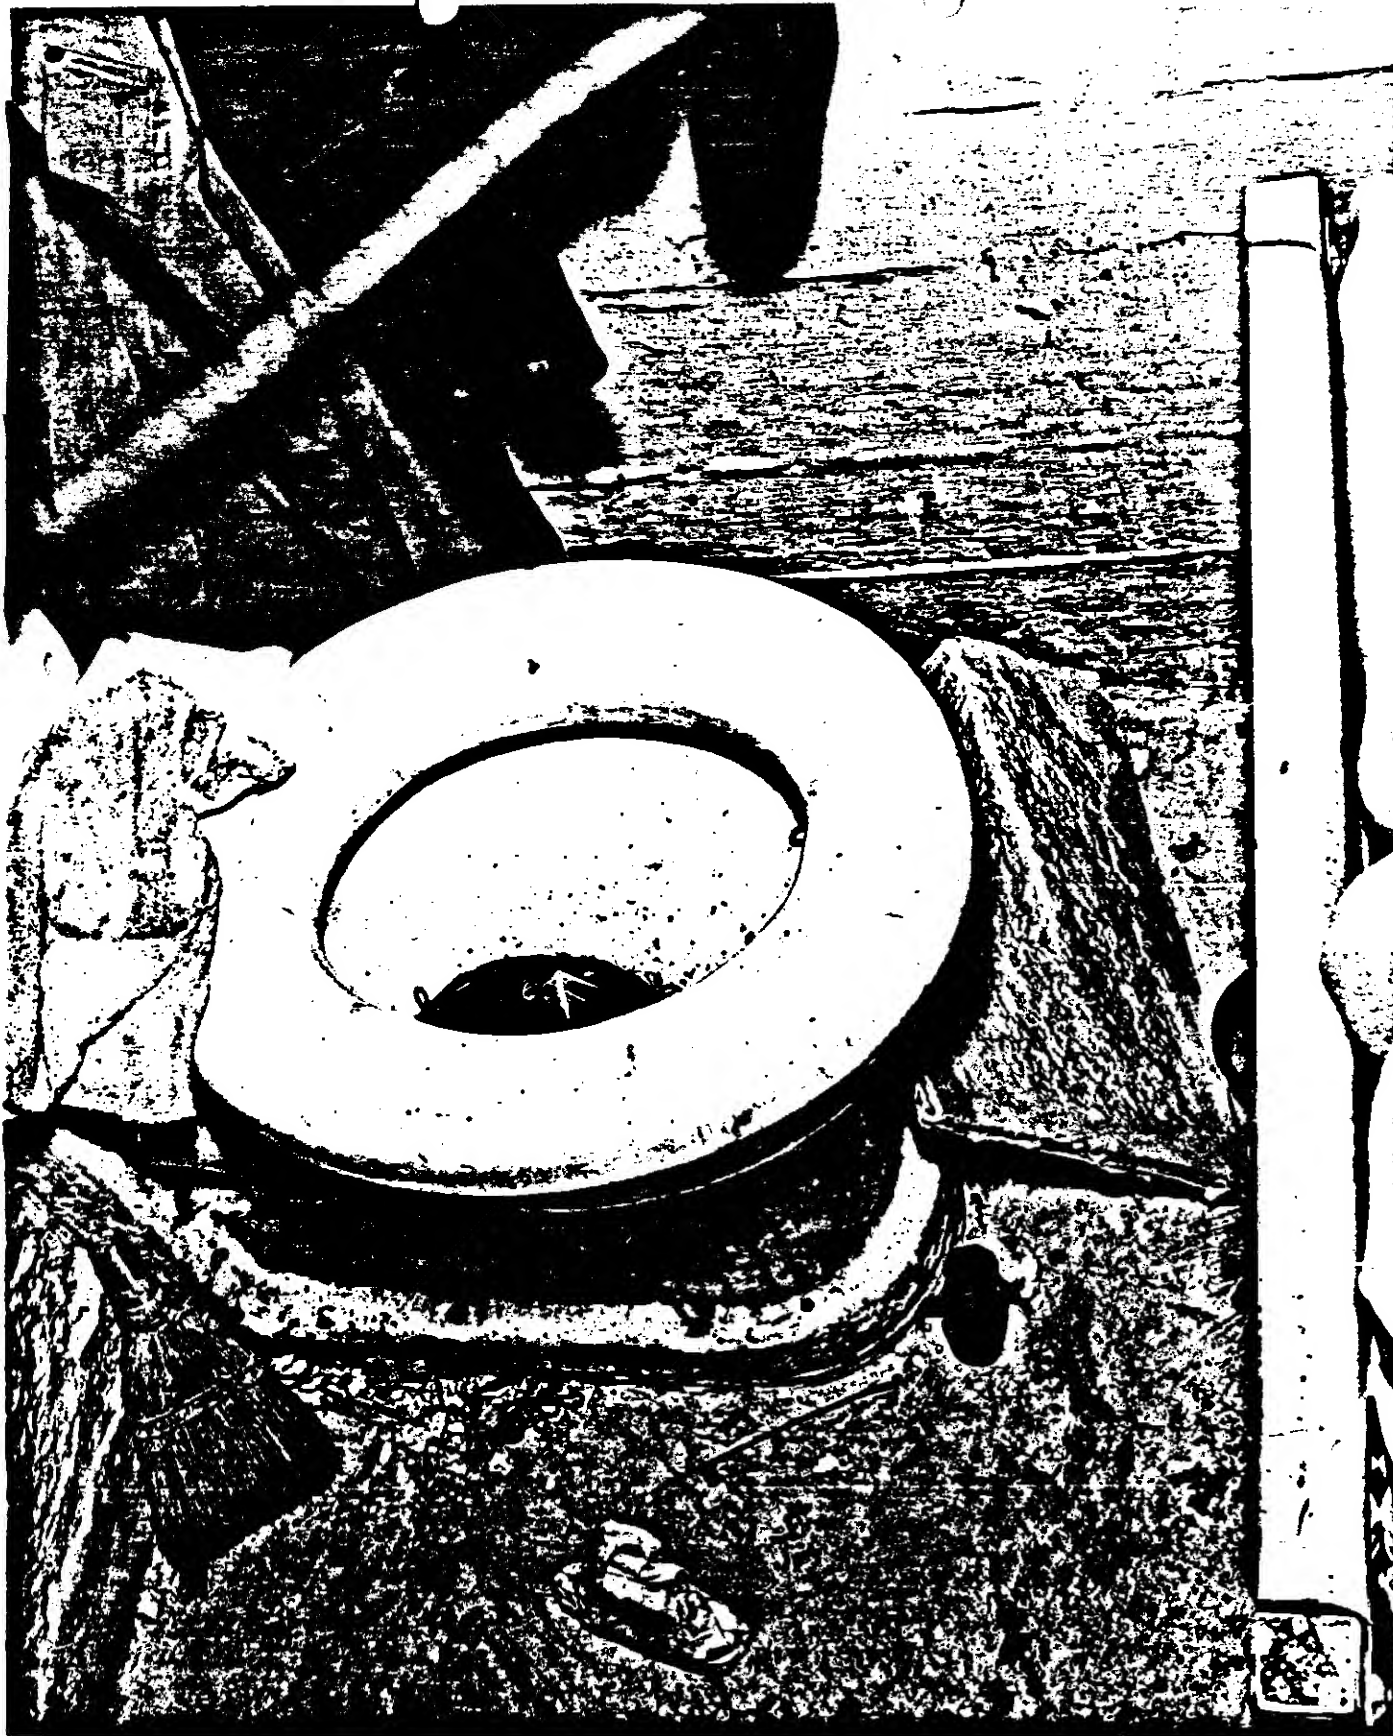
3-4

Photograph taken in the cell of CLARENCE ANGLIN showing detail of toilet facility at foot of bed. Portions of soap scraps and plaster are visible as are fragments of hair. Immediately forward of the toilet seat is a portion of the grill made by Subjects to replace that removed from the cell. The portion of the small circular object seen is the cup which is supplied to prisoners for shaving purposes. This cup contained water and a brush.

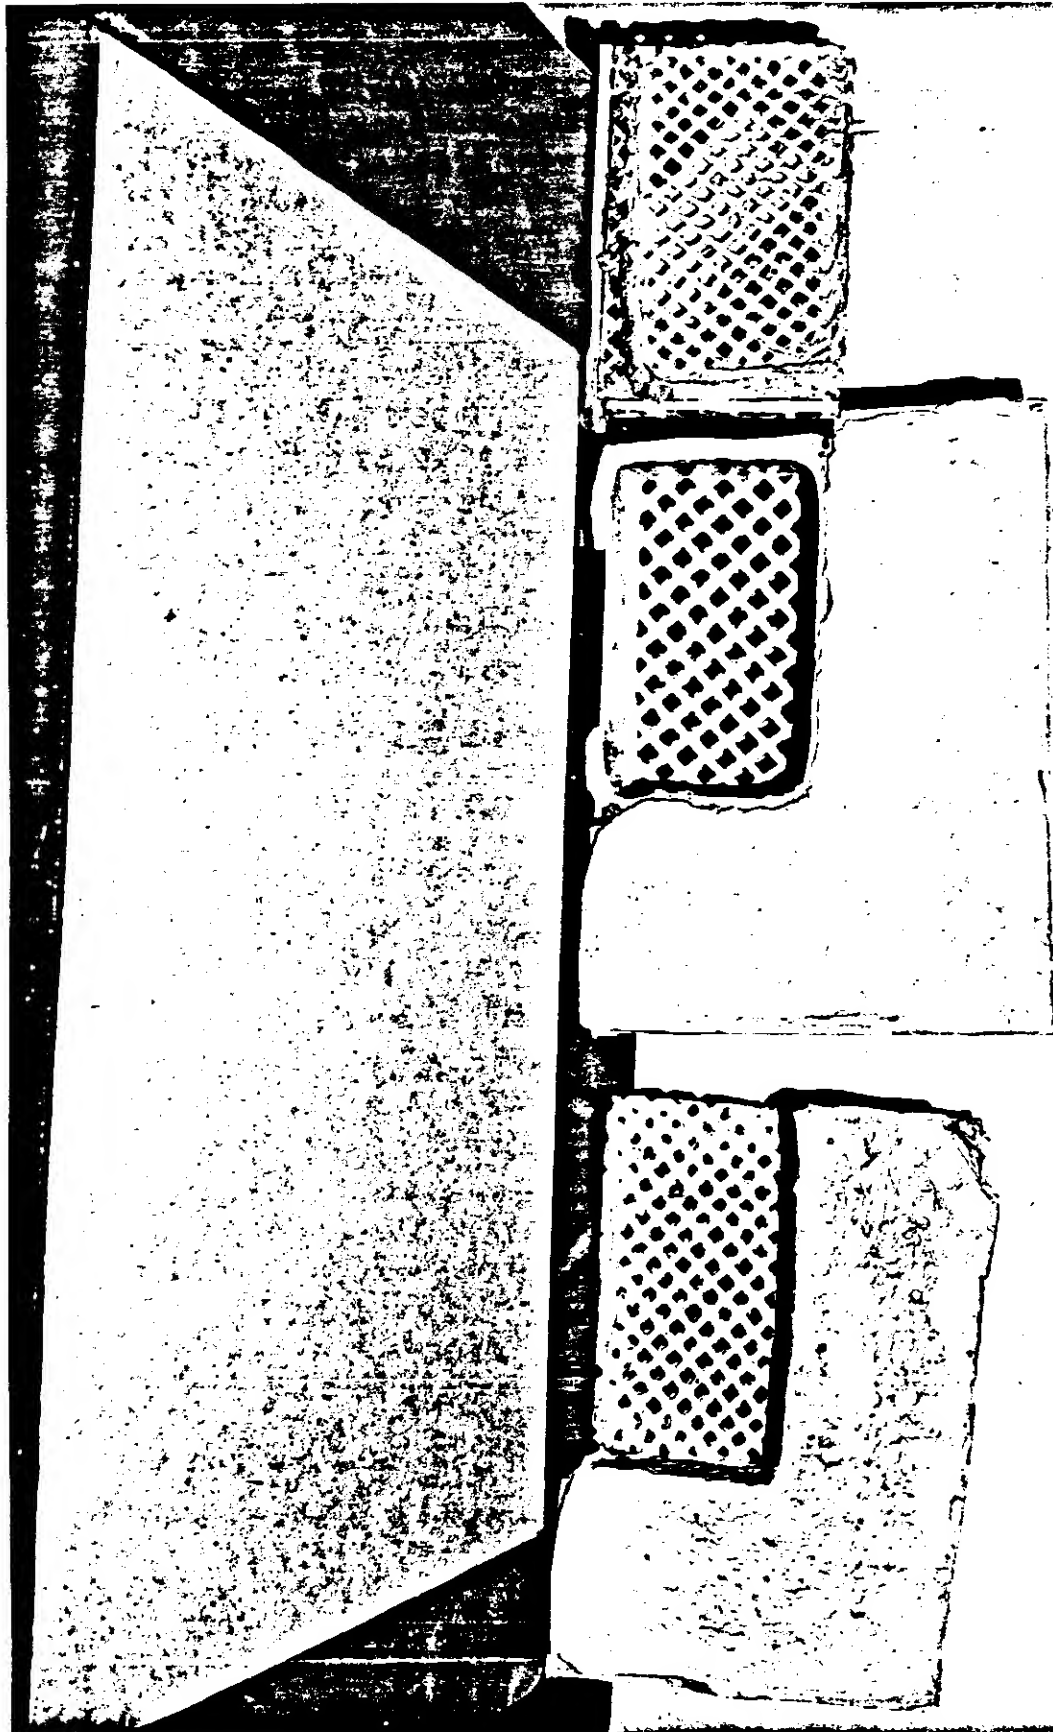
Replicas of ventilator grills placed in openings in cells through which Subjects exited to utility area between cell blocks B and A. Replica on the left is the actual size of the metal grill originally in the wall; it was reproduced, as were all the rest, from artist's drawing board which was faced with a linen-type substance. This material is available to all inmates for art painting purposes.

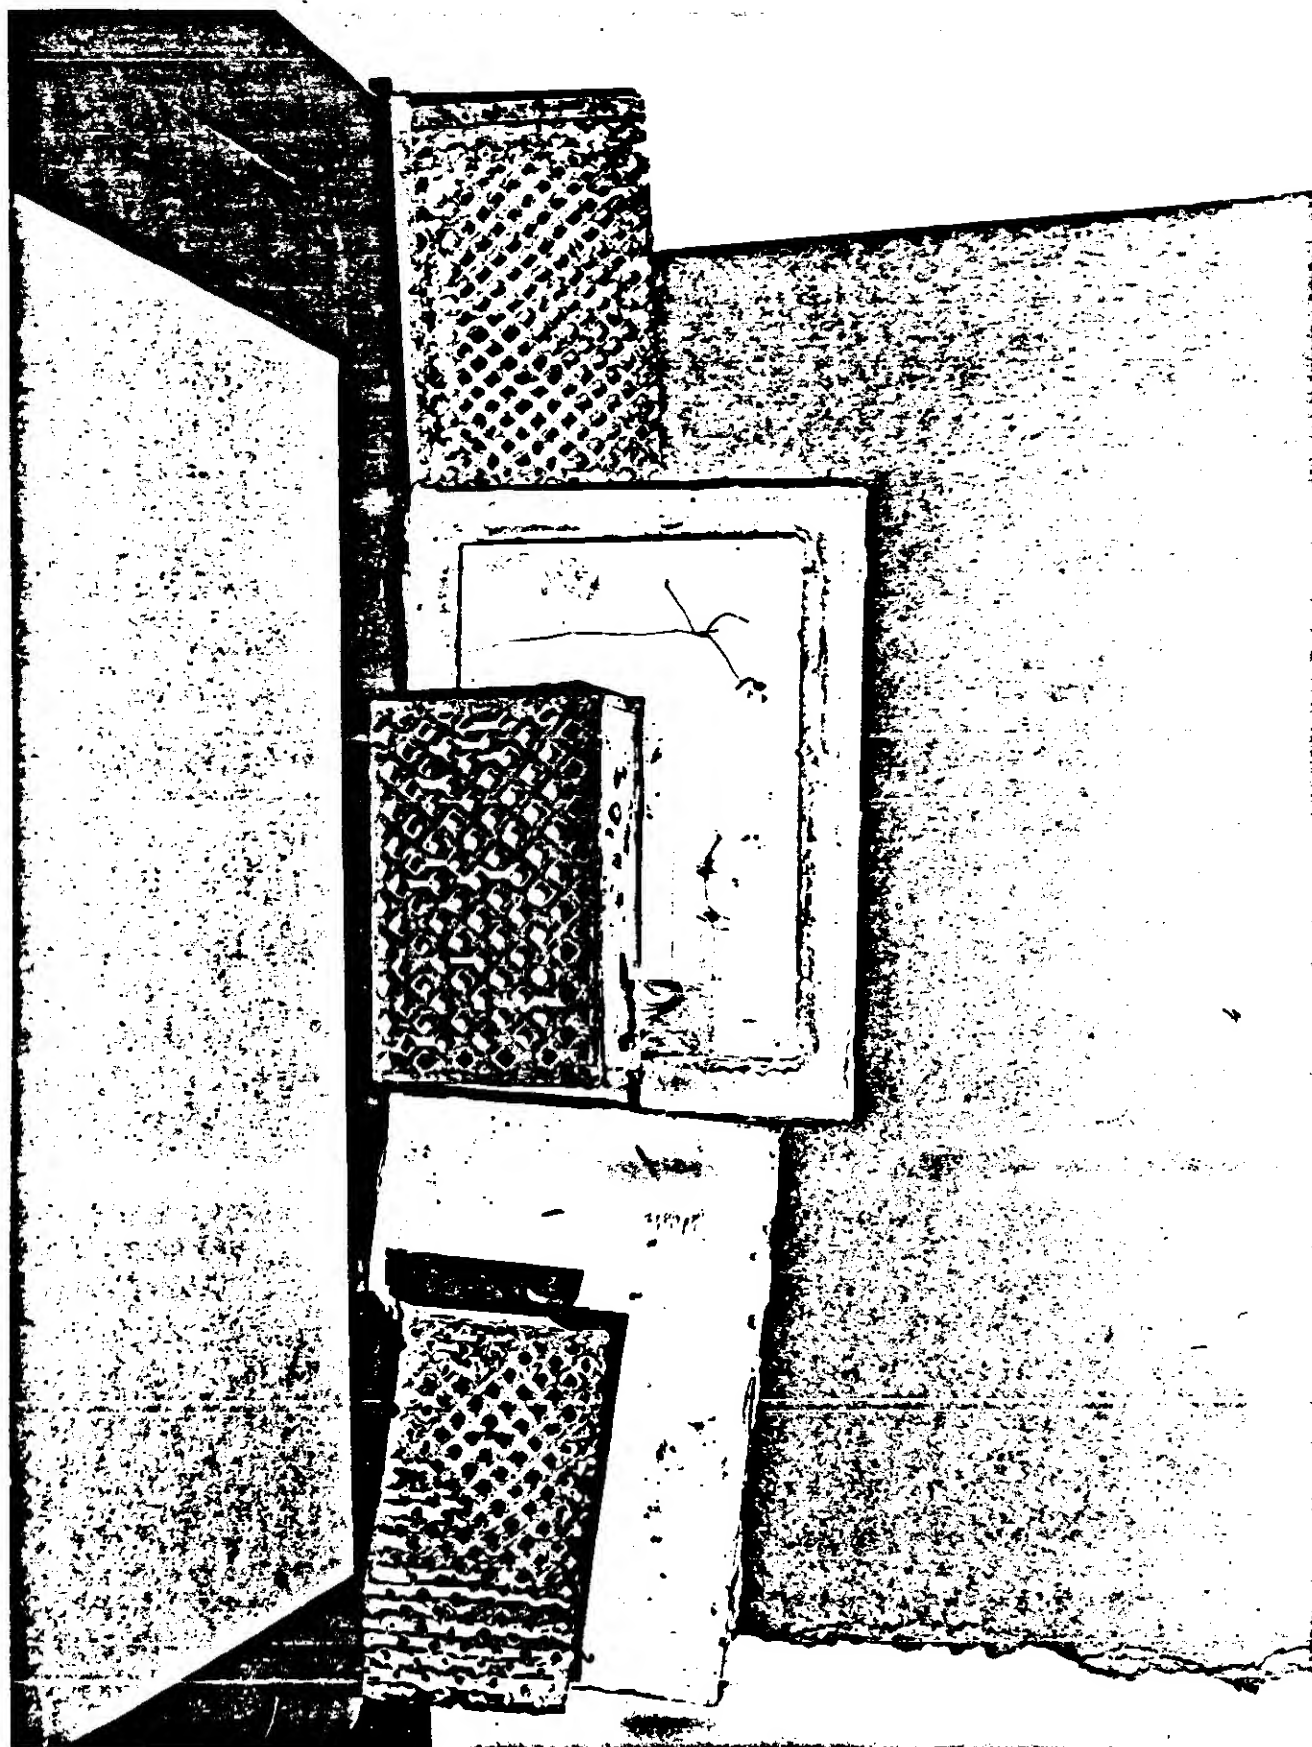
Rear view of three replicas of ventilator grills used by Subjects to replace original grills in their three cells. Note wire hooks by which grill and surrounding surface could be pulled into place after Subject's exit into the utility area.

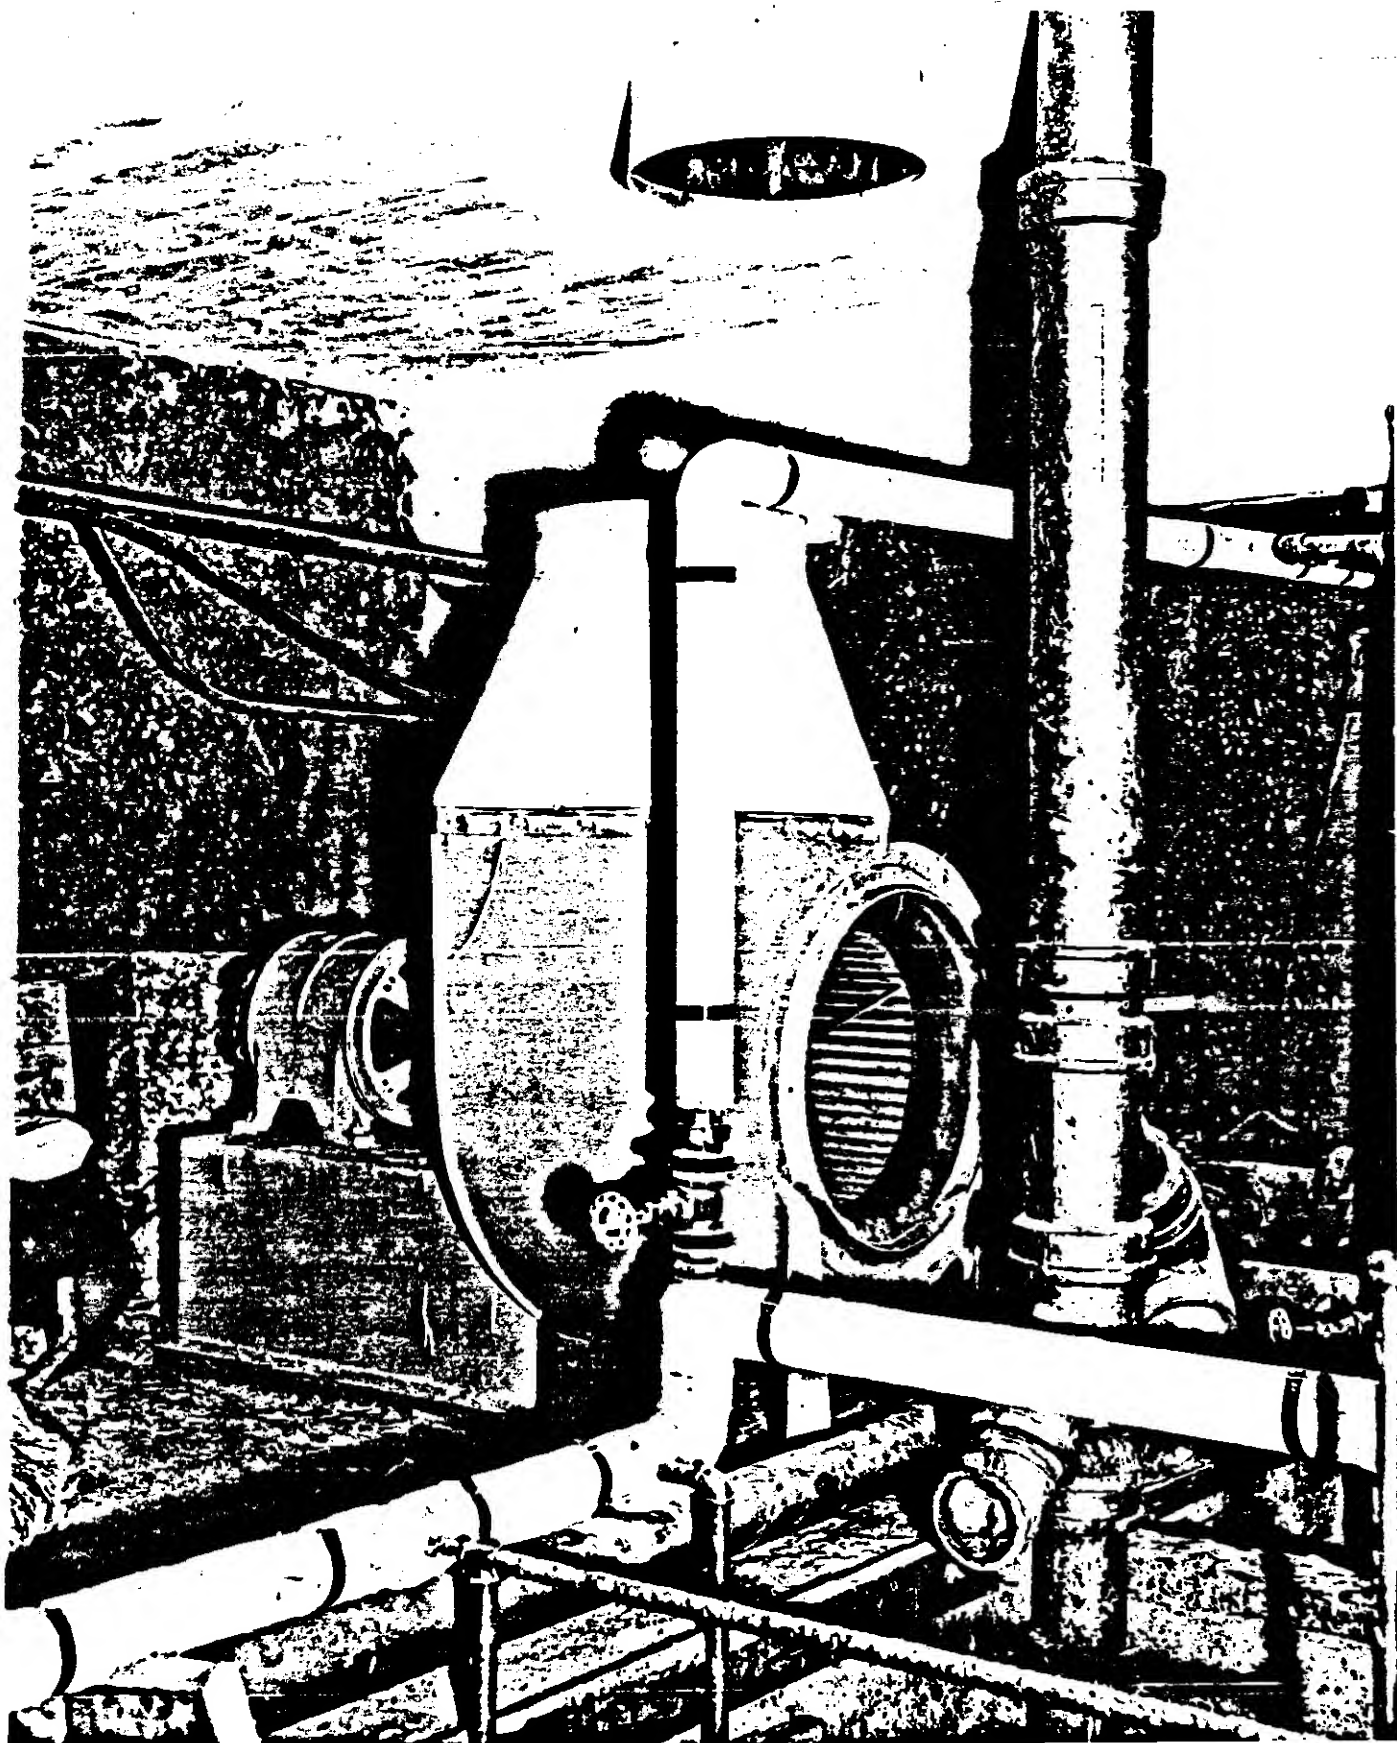
3-10 Photograph taken of the abandoned ventilating fan with opening through to the roof. Left rear and center background shows the manner in which this area was completely enclosed by drop cloths and blankets hung ostensibly to prevent splattering of paint into the cell block.

It was in this ventilator that the abandoned pantoon and two bundles of raincoats were located. Articles at the bottom of this ventilator could be reached by a long pole which had a nail protruding and could be used as a hook.

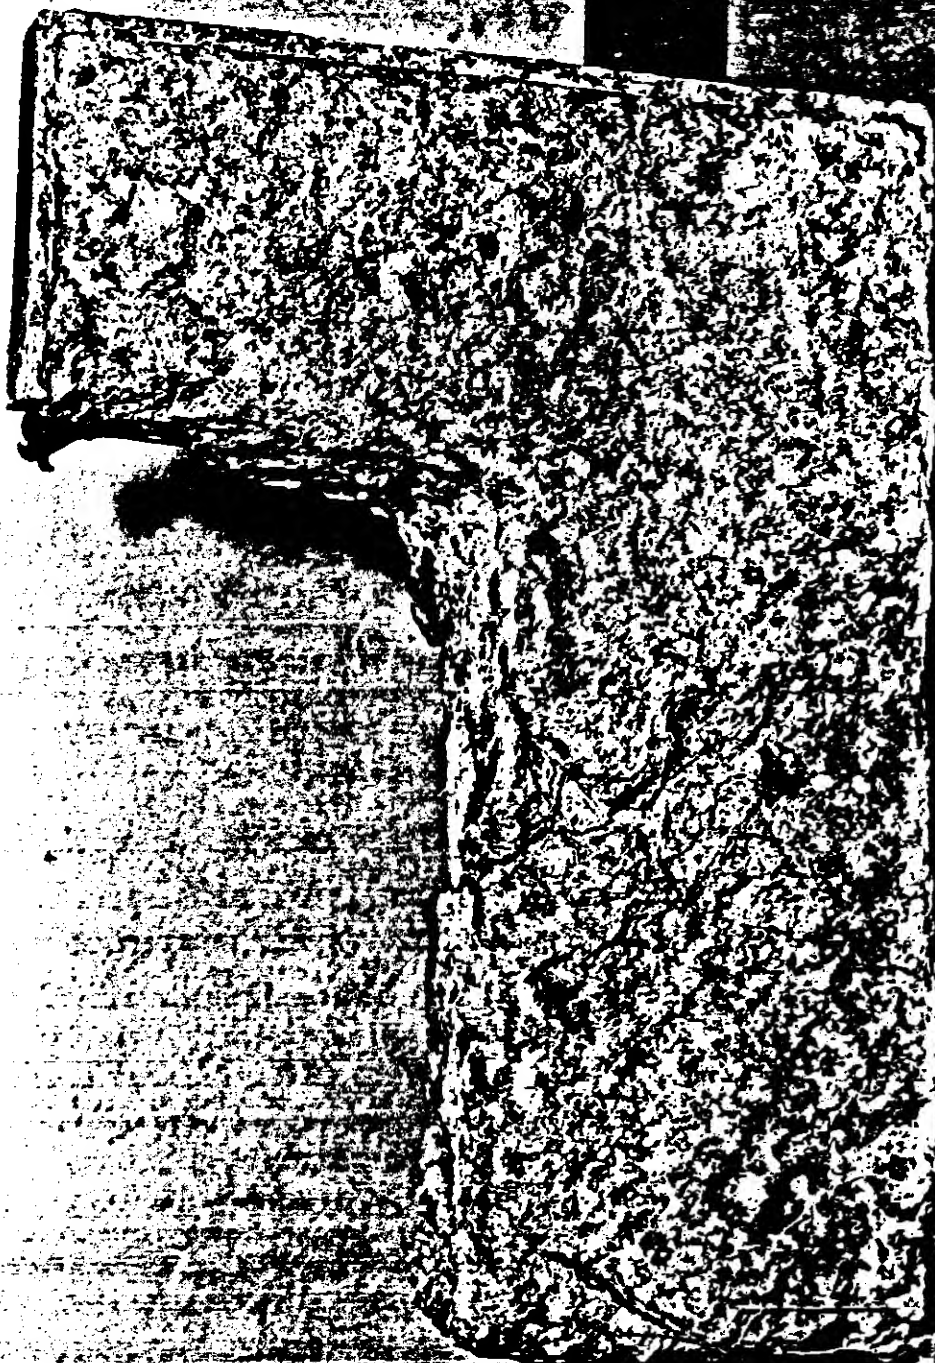
Concrete replica: this is the reproduced utility wall surface made to replace the concrete removed in order to avoid detection by a guard check along the utility corridor. This concrete was applied to hard board.

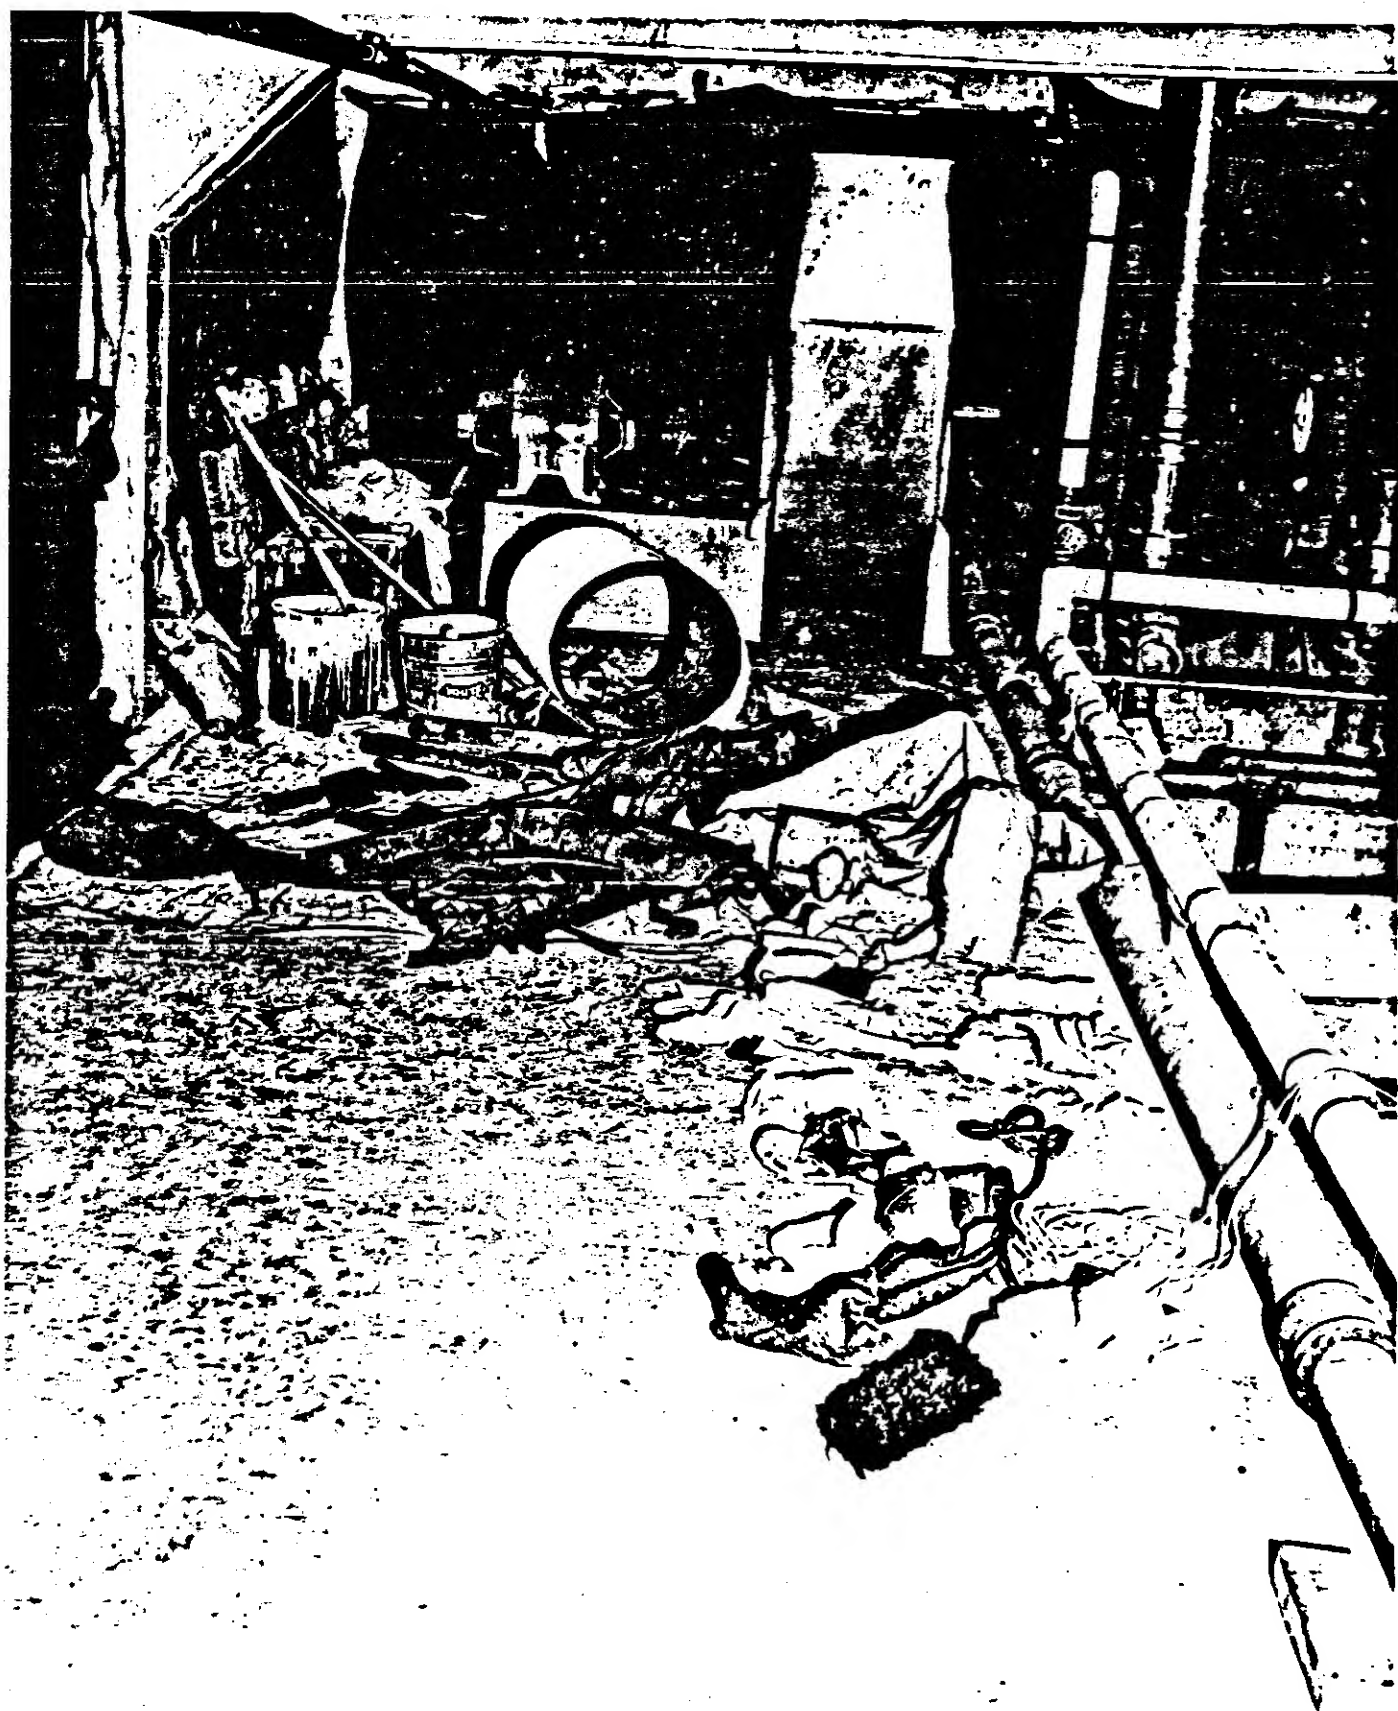
3-11 A general view looking toward the end of Cell Block B. The portion of the blanketed grill wall seen across the upper portion of the picture was across the end of the cell block. Approximately directly opposite the large black cast iron vent seen in upper right and down on the main floor was the main entrance to the entire cell area. The blanketed or screened-in area covered an area approximately thirty to thirty-five feet in length from the end of the cell block and extending on both sides, giving perfect concealment.

At lower right center may be seen a white cord which was tied to the hot water pipe crossing between Cell Block B and C and was one inch in diameter. This cord was lowered down the utility shaft and upon reaching the bottom, which was directly behind Subject's cells, it was determined to be twenty-six feet ten inches. Sections of this cord were knotted at intervals which apparently indicated the tier level reached when lowering or raising the rope. Fragments of raincoat material may be observed in general debris in center of picture. The five-gallon paint bucket from which a stick is seen protruding contained hardened cement paint and it was in this bucket a number of the Subjects' tools were subsequently located.

The heavy plank extending across the chair may have been used as the weight necessary when "vulcanizing" the seams on the raft and "Mae West" jacket.

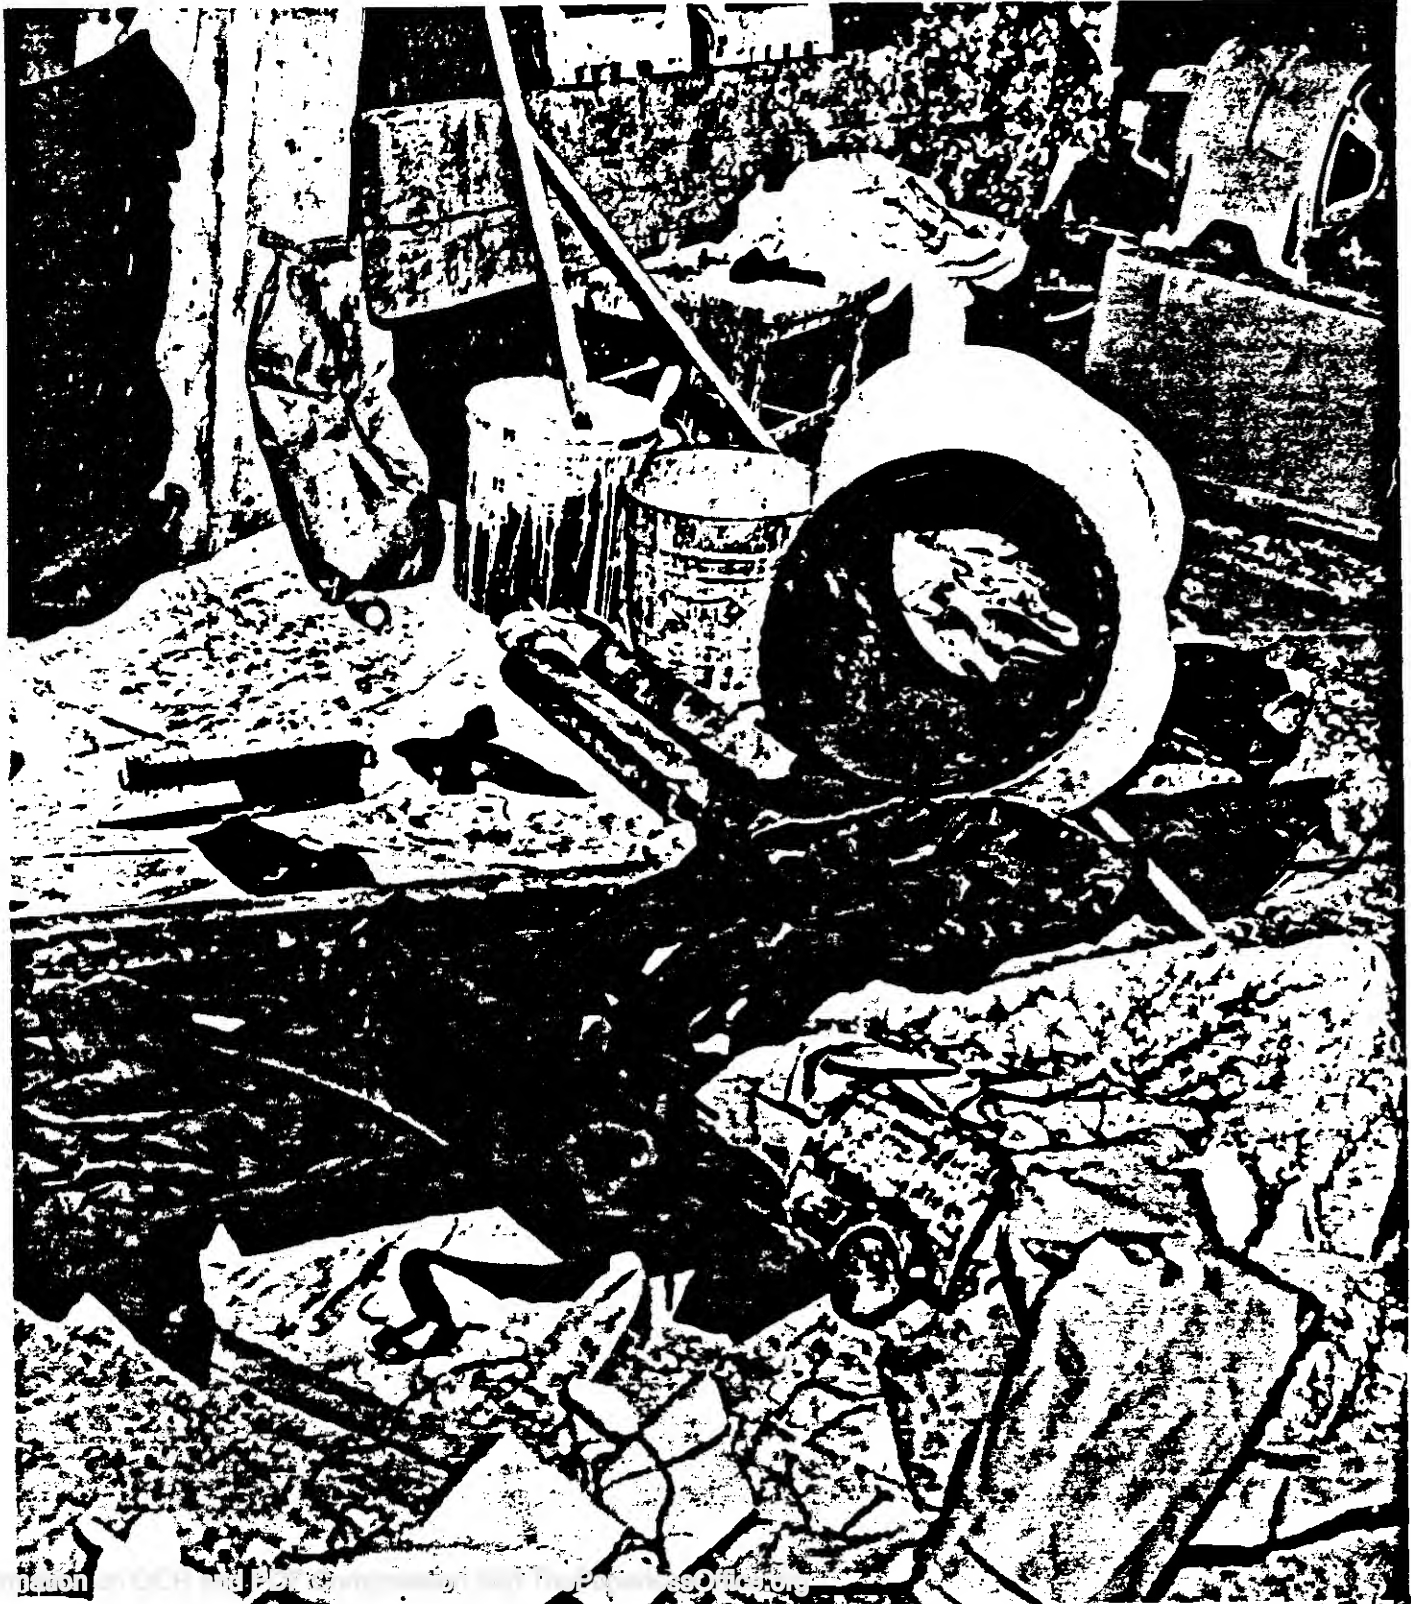
3-12 General view taken approximately fifteen feet from the bucket seen in center foreground. Lower left center are pieces of white Navy blanket cut in strips. The material seen at lower right is a type believed to have been used in making the raft. The goosenecked connector from the ventilating motor to the roof is seen in upper right. On the chair may be seen the remains of some brass bolts which were either machine or electrical bolts and brass washers and nuts identical to those found in the paddle.

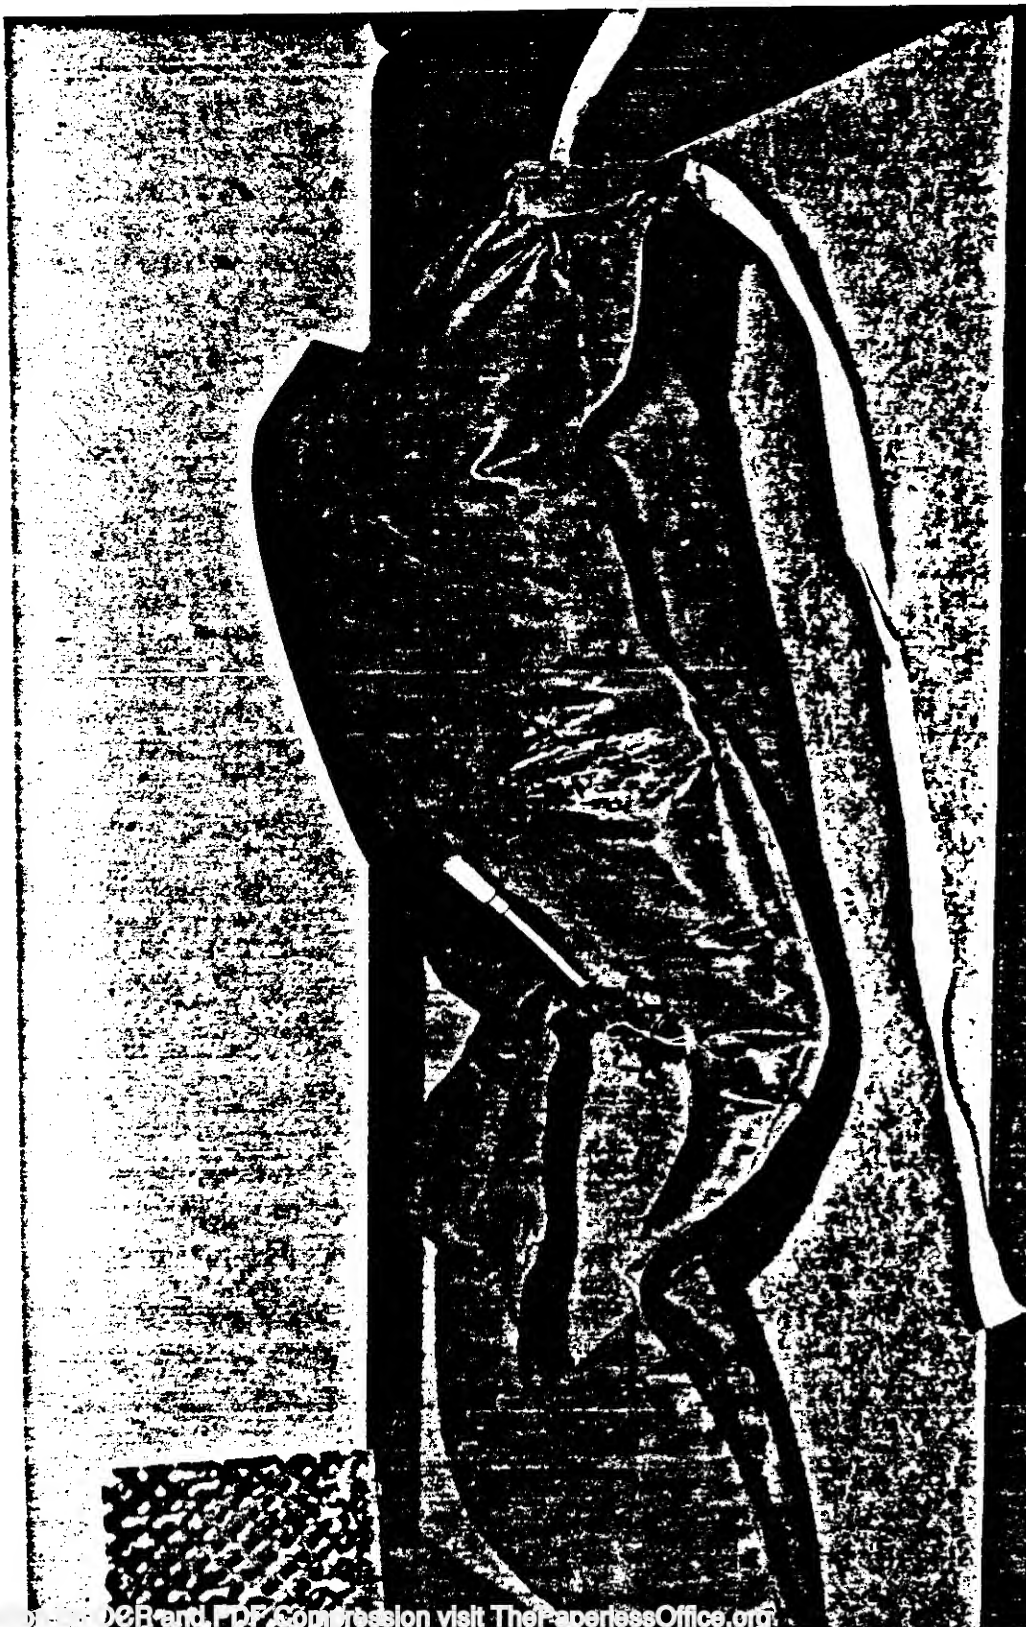
Close-up view of "yoke type" or "Mae West" life preserver showing the seam which appears to be sealed by a vulcanization type treatment, achieved by the application of heat and pressure. The heat was readily available through an exposed 1" copper hot water pipe approximately four feet long which crossed from cell block B to cell block A and was located over the top of the third tier of cells and crossed the utility well. The pressure was readily available through the use of a large heavy section of planking located in this area.
